## 1. Visible Oil Staining Means the Refrigerant Leak Has Probably Already Started — Check the Liquid Line and Suction Line Together

## 2. Insulation Pulling Away from the Copper Is a Condensation Problem Waiting to Happen — Especially in Humid Climates

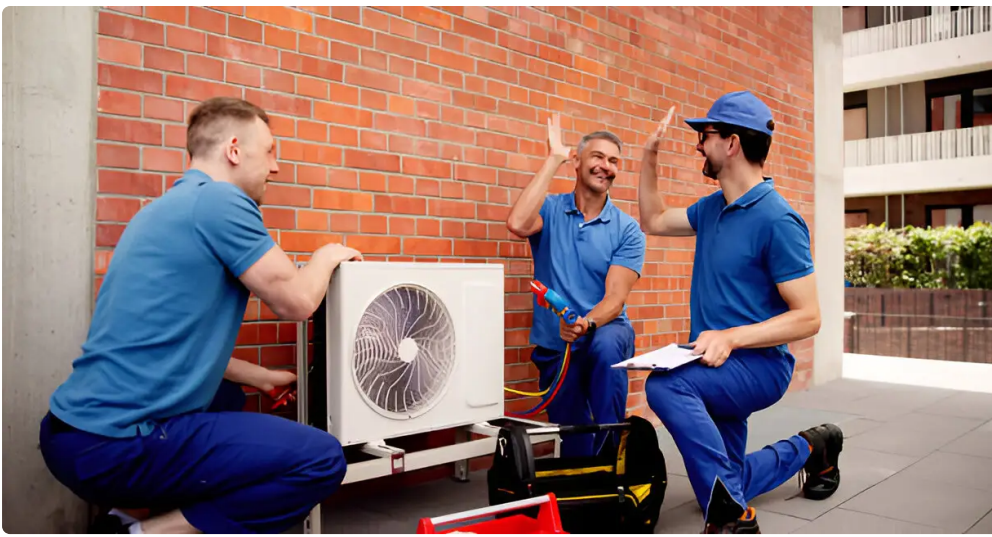
What is the difference between pre-insulated and field-wrapped line sets? A factory **pre-insulated line set** arrives with uniform coverage, tighter adhesion, and predictable thermal performance, while field wrap depends heavily on installer technique and often leaves seams or compressed spots. In humid conditions, those weak areas become condensation points.

An insulation rating above **R-4.2 insulation rating** is a meaningful threshold on exposed suction lines because it slows heat gain and helps prevent sweating under real summer load. Lower-performing foam around R-3.2 may look fine on day one, but once it compresses or gaps, performance drops further.

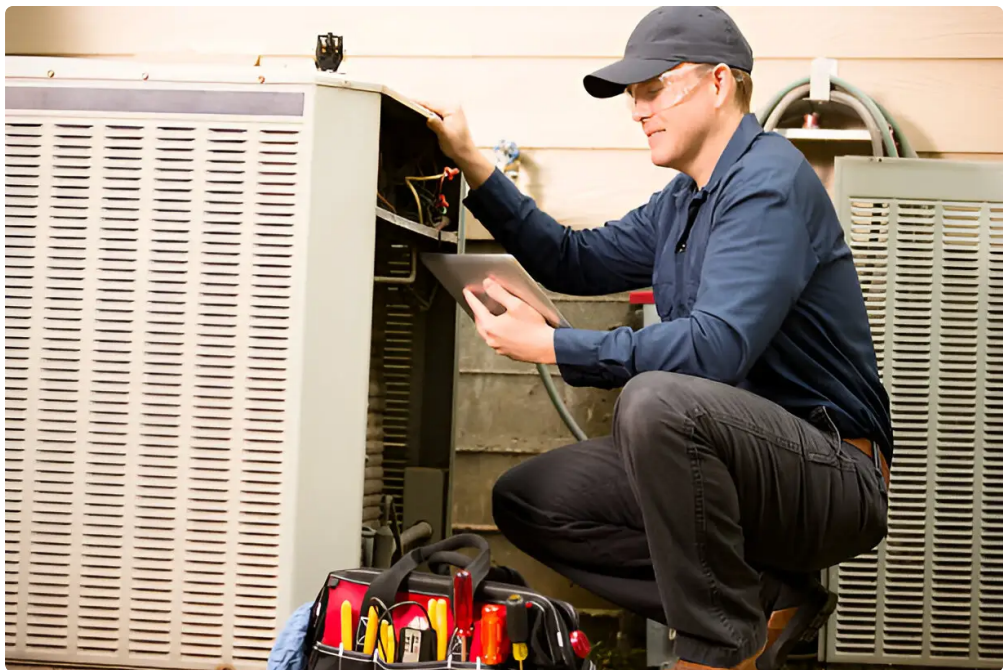
A pre-insulated line set comes from the factory with bonded insulation already installed around the copper. A field-wrapped line set requires the installer to add insulation on site, which takes longer and introduces more chances for gaps, compression, and moisture entry.

In practice, factory insulation usually produces cleaner results because the jacket thickness stays more uniform and the bond tends to be more consistent around bends. Field wrapping can work, but it depends heavily on the installer's technique and the jobsite conditions. Seams, stretched tape, and compressed corners are common weak spots, especially on tight wall penetrations or rooftop routing. On a busy service day, pre-insulated assemblies can eliminate about 45 to 60 minutes of labor compared with building protection in the field. They also reduce the risk of condensation in humid climates because the vapor barrier is more controlled. For exposed outdoor sections, the quality of the outer jacket matters just as much as the foam inside it.

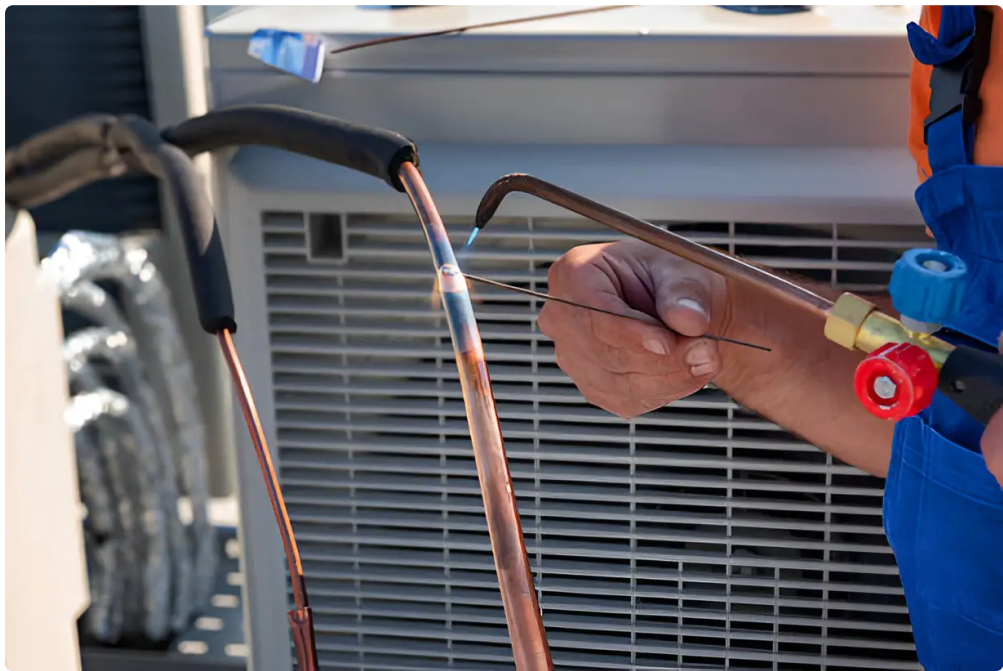
Insulation separates when the foam jacket doesn't bond well to the copper, gets overstressed during bends, or breaks down from heat and UV exposure. Once a gap forms, humid air reaches the cold line surface, and condensation begins where the insulation is no longer fully in contact.

The first bend near the indoor or outdoor unit is the most common failure point because the copper changes direction sharply while the foam wants to stay straight. Lower-quality materials often tear or pull away right there. Over time, sunlight, thermal cycling, and handling damage can worsen the separation. In Gulf Coast and Southeast climates, that small opening can create enough sweat to stain drywall or feed mold inside a chase. If the insulation rotates around the tubing or feels hollow when pressed, it has likely already lost adhesion. At that point, tape may cover the symptom but usually doesn't restore the thermal performance or vapor barrier integrity you need for long-term reliability.
